**RE: Excelsior Beach to Bay Condominium
DEG File No. 203952
Observation Report**

As per our agreement, **De Stefano Engineering Group, PL (DEG)** has completed a limited condition survey of building, the building perimeter, and related elements at the above referenced project. Our review also included observations of the fenestrations.

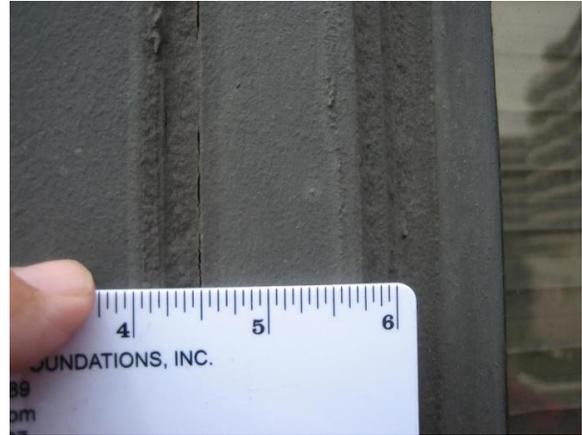
During adhesive failure, the sealant separates cleanly from its substrate. This type of failure will result if the sealant is applied to a dirty or wet surface, or if the substrate is contaminated by a material – such as paint or a waterproofing coating – that will discourage a strong bond.

Adhesive Failure

Sooner or later, all sealant will fail, even if it has been properly specified and applied. When failure occurs, it is important to replace the failed sealant material as soon as possible to prevent water from entering the building envelope and to ensure that the joints properly accommodate movement from thermal expansion and contraction, wind loading, and moisture.

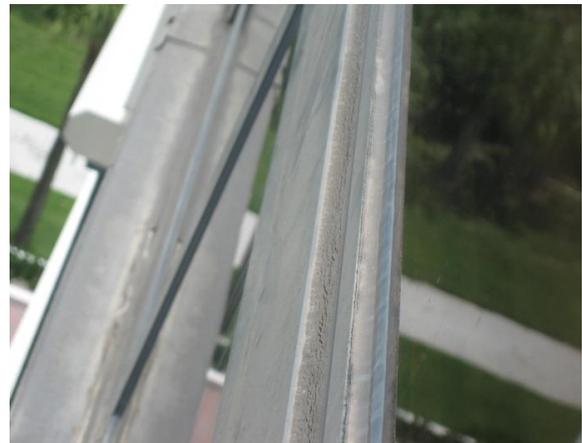
During cohesive failure, the sealant is split within itself. Improper joint design—including an inadequate number of joints and incorrectly sized or located joints—is a leading cause of this type of failure, as is the installation of an inappropriate sealant. Each type of sealant has specific performance characteristics not suitable for every installation.

Cohesive Failure

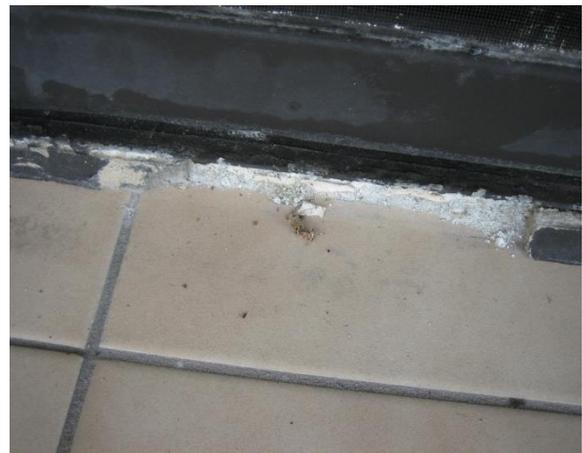
Substrate failure occurs when the sealant remains tight to the substrate, but the substrate separates from itself. This type of failure takes place when the adhesive and cohesive strength of the sealant is greater than the cohesive strength of the substrate.

Substrate Failure

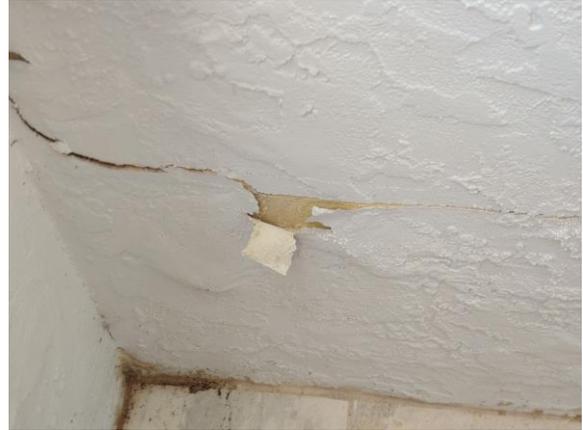
Blistering Paint Coatings

Blistering is the formation of round 'bubbles' of paint film. The cause is always moisture related. This is usually caused by excessive moisture coming through the substrate or sometimes it is caused by improper surface preparation.

The elastomeric coatings currently installed on the structures appear to retain their elastomeric properties and waterproofing qualities. However, the aesthetic issues need attention. Therefore, we do not recommend installing another elastomeric coating, but a high-quality acrylic coating.

The advantages of using the acrylic coatings are better color retention, less dirt retention, less biological growth, and reduced cost. The breaches in the elastomeric coatings will have to be addressed and properly repaired.

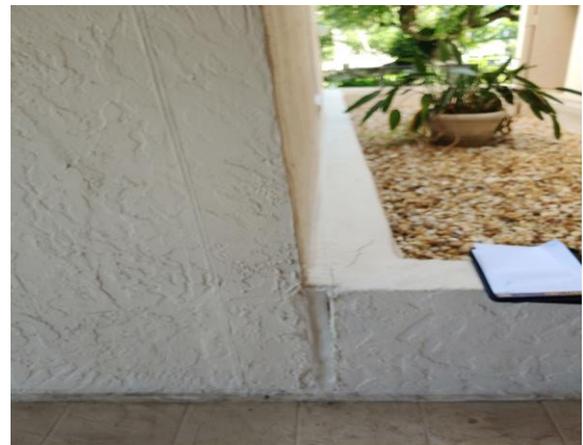
There are expansion joints about midspan of the building. At these locations, the slab or beam rests on steel angles. The joints have been filled with sealant which appears to have been installed to prevent these areas from leaking. These joints are about 1-1/2" wide. The sealants are not designed to span this distance. These locations require a true manufactured expansion joint. This will allow the building to move as intended without overstressing the joints.

Further, these angles need to be coated with the building, so they do not rust. Should these angles corrode, replacing them would be a costly venture. At the time of our observation we only observed surface rust.

Expansion Joints

- ❖ Repair the existing membrane system and topcoats on the Gulf side walkways.
- ❖ Remove and replace some of the walkway railings.
- ❖ Remove and install a prefabricated expansion joint.

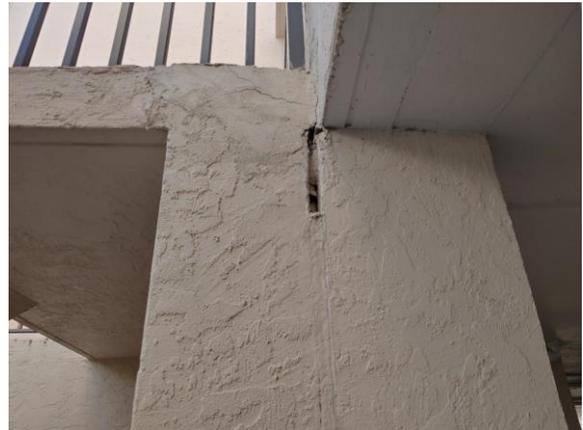
Expansion Joints

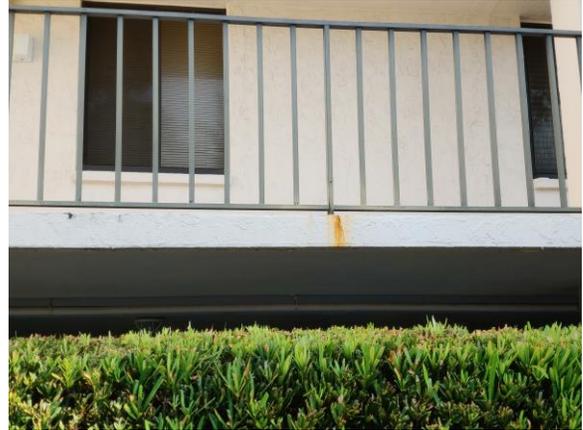
Some of the walkway railings on one building have been replaced. These seem to be in good condition. Some of the existing handrails are beginning to deteriorate and are approaching an unsafe condition. Further, these rails are no longer code compliant.

Walkways Railings

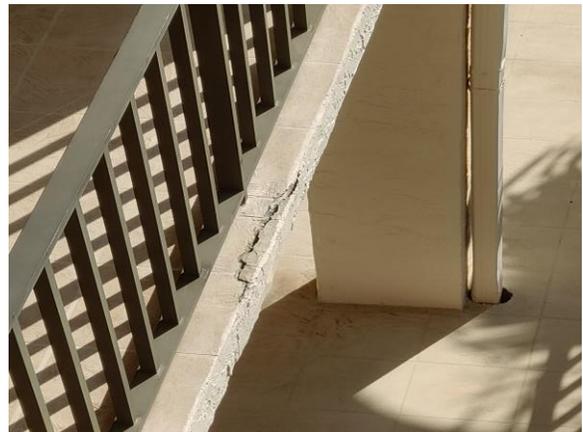
Concrete Repair

The structural components at the Condominium are corroding because of the process described above. Generally, this deterioration becomes significant after 20 to 30 years.

- ❖ Remove and replace the sealants.
- ❖ Repair damaged concrete and masonry by removing concrete near corroded reinforcing steel, cleaning and preparing reinforcing steel and installing repair mortars. Since the success of repairs of concrete damaged by corrosion of reinforcing steel is highly dependent on the method of repairs, the International Concrete Repair Institute (ICRI) has compiled guidelines for repair methods based on research and the experience of engineers, contractors and material manufacturers worldwide. These guidelines represent the current understanding of correct methods for durable repairs. DEG recommends repairing damaged concrete according to ICRI guidelines. The success of repairs is also dependent on the materials used in the repairs. We recommend using repair materials that have been engineered specifically for the repair of corrosion-damaged concrete.

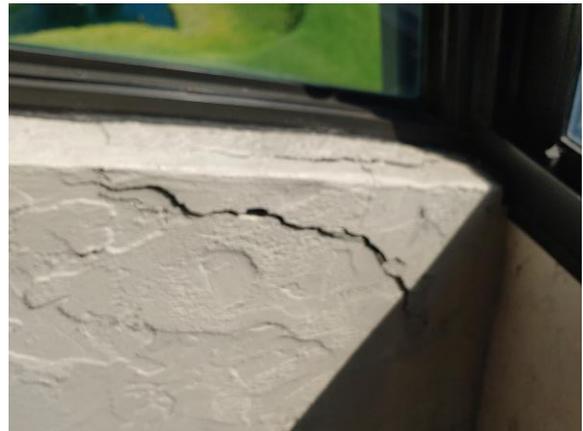
Concrete Repair

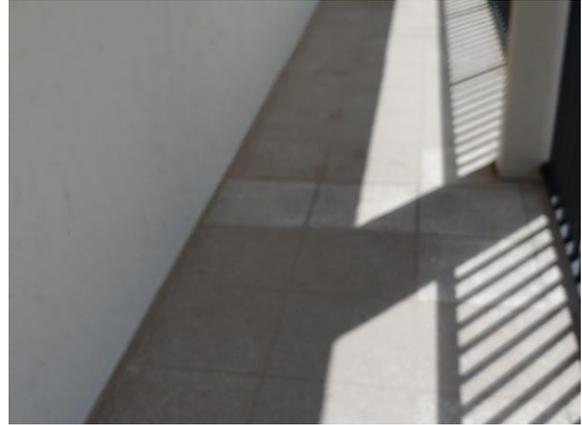
Walkways Coatings

The current systems installed on the building are cementitious. The Gulf side building has a decorative colored membrane which appears to be holding up well. Several locations need to be repaired. The advantage of these systems are they can be recoated as the membrane appears to be intact. At the areas where concrete repairs are located, the membrane system can be repaired and blended into the existing systems. Then the entire system can be recoated and maintain the original appearance.

In the bayside buildings, there is a decorative cementitious coating as manufactured by a company called ProTile. This is more or less a polymer modified stucco. There is no membrane beneath the coating. This coat has a susceptibility of cracking a delaminating as can be seen at several locations. These can also be repaired, however these systems are not waterproof as they are without a membrane. These systems can be removed, a membrane installed, and the ProTile again or a membrane system like the Gulf side walkways.

- ❖ Remove the existing decorative coating and membrane on the bayside building walkways and install a membrane system with decorative finishes and topcoats.

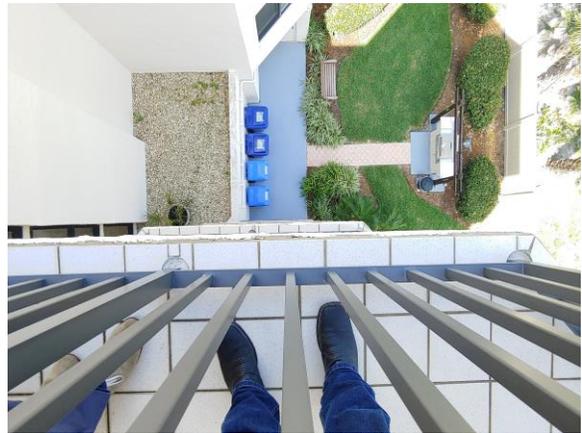
DEG observed some locations where the stucco is delaminating. Stucco is an exterior plaster, which has historically been used to weatherproof and in some cases decorate building exteriors. Although stucco is nonstructural, it offers a protective coating and prolongs the life of the building.

Stucco Repair

- ❖ Install galvanic anodes at repair areas to reduce the potential of the halo effect at areas where the migrating corrosion inhibitors cannot reach, such as under walls.
- ❖ Remove and replace delaminating and failing cementitious finishes.
- ❖ Remove and repair the areas of paint that are blistering. Paint the building with a high build breathable paint coating.
- ❖ Remove and replace some of the existing screen enclosures.

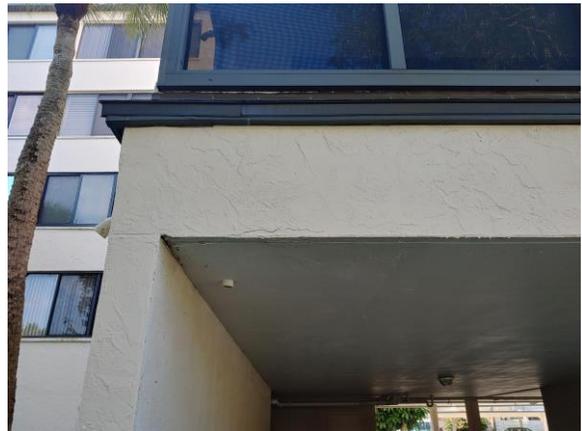
Concrete Repair
