Excelsior Restoration Update

6-18-2021

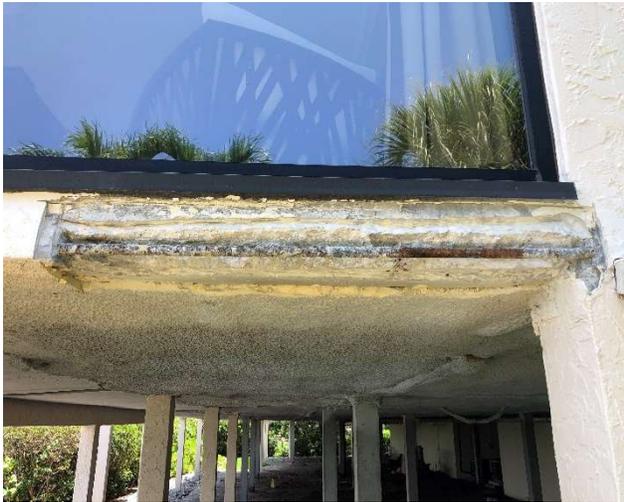
Exposed Rebar on N.Villa

North Villa – This building is substantially completed with the exceptions of the five support columns that need repaired. These will be done when we have a few days of rain given they are weather protected.

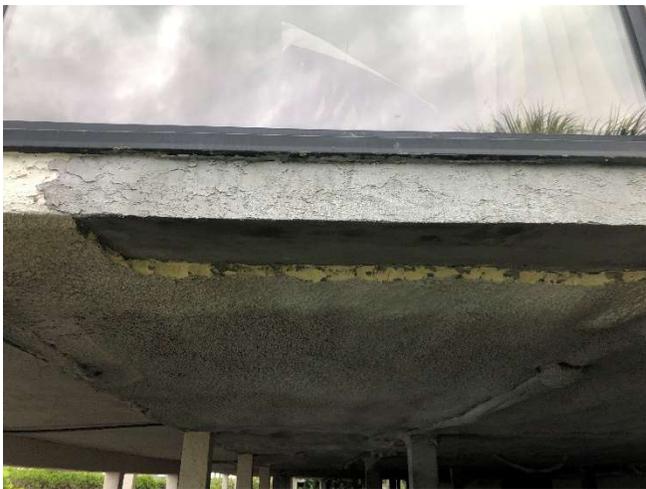
Finished product, prior to paint.

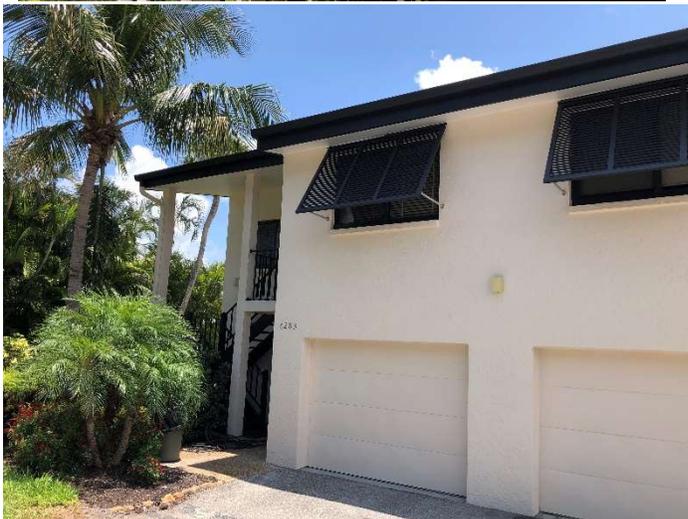
Finished product

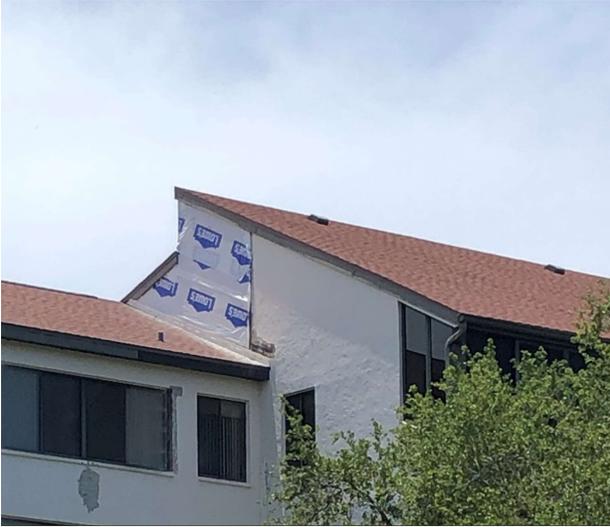
Tyvek protecting the wood.

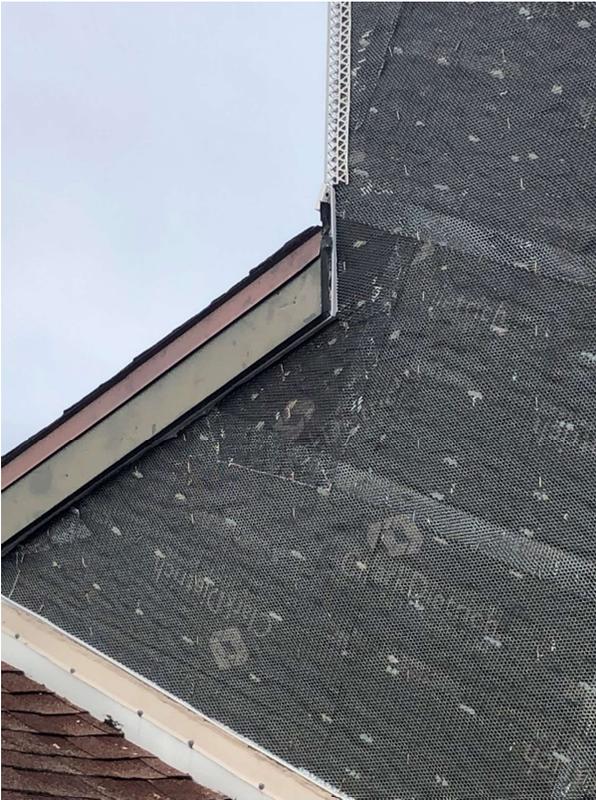
Proper edging, Lathe and underlayment, over the Tyvek.

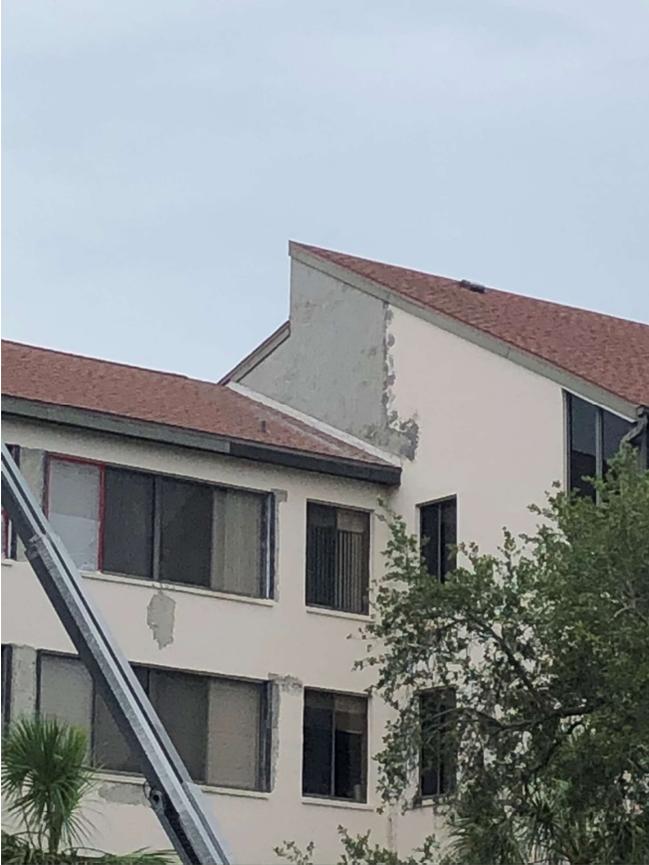
Stucco has started on upper sections.

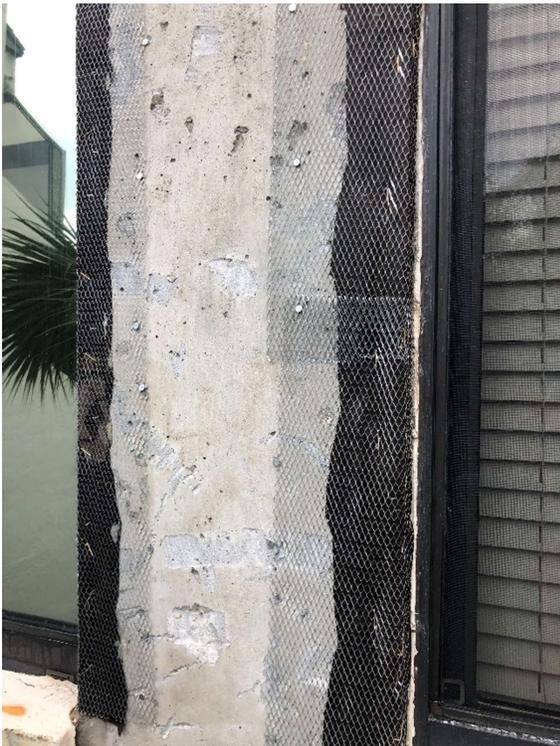
Lathe added around all windows for added strength of the stucco and sealants. Not there in the original construction.
