Excelsior Restoration Update

8-27-2021

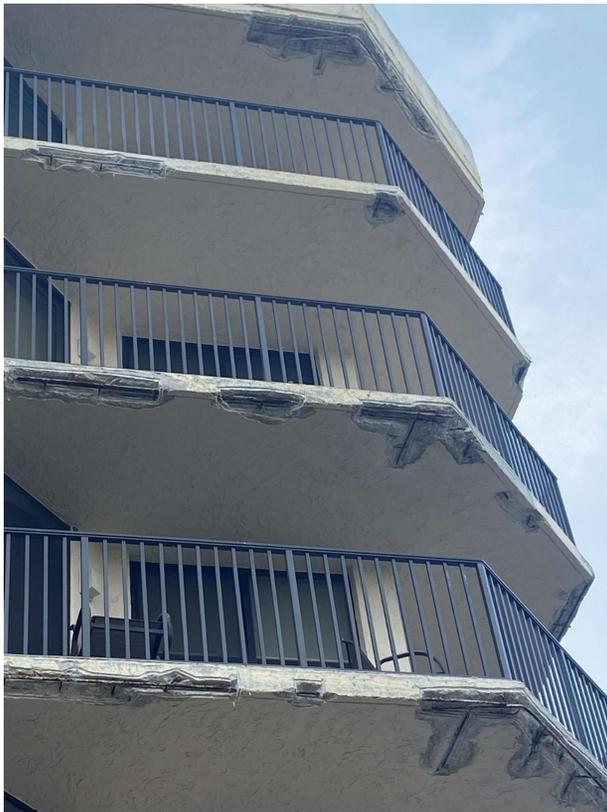
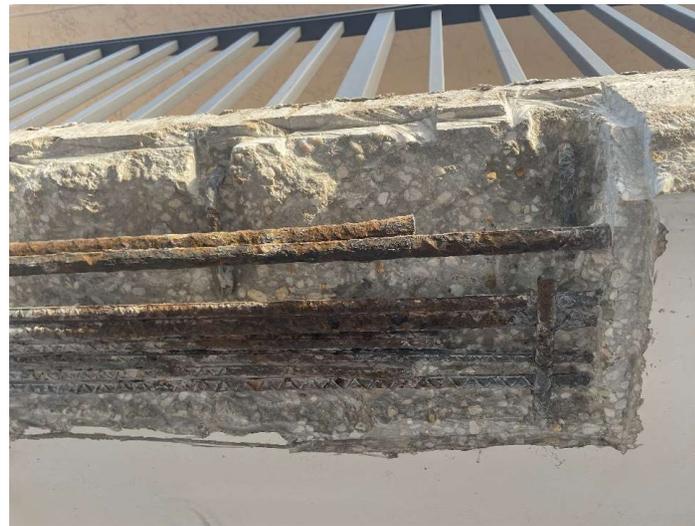
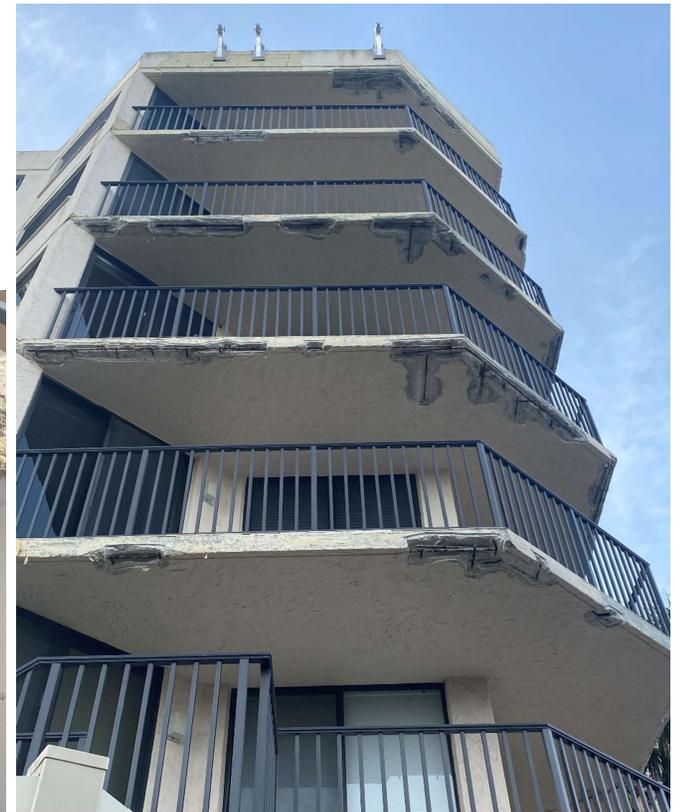
Gulf Building Photos Restoration

- D&D are finding a great deal of leading edge issues on all of the lanais and walkways as can be seen in the photos below.
- Our Engineer from Kerins has required us to get a shoring engineer to help us safely shore a column along a slab on the west end.

- We are finding rusted rebar runs nearly full length under at least one lanai.
- Just an FYI, when rusted rebar is found, it is a code requirement that you chip out the concrete around the rebar under “clean” rebar is found. If you don’t, within a couple of year, you will be fixing the issue again.

- Couple of things we have learned from D&D and the Kerins Engineering
 - Very few, if any condos, put tile down on exposed lanais or walkways. The membrane under the tile only has about a 10yr life at best and there is no way to replace it without removing the tile. Our tile floors on the lanais are 40yrs old and a couple of broken tiles popped out and there was water underneath them. This may account for the rusted rebar towards the center of one lanai.

- Same thing on the walkways. It is clear that the waterproofing membrane has failed and letting water seeping into the concrete along the leading edge.

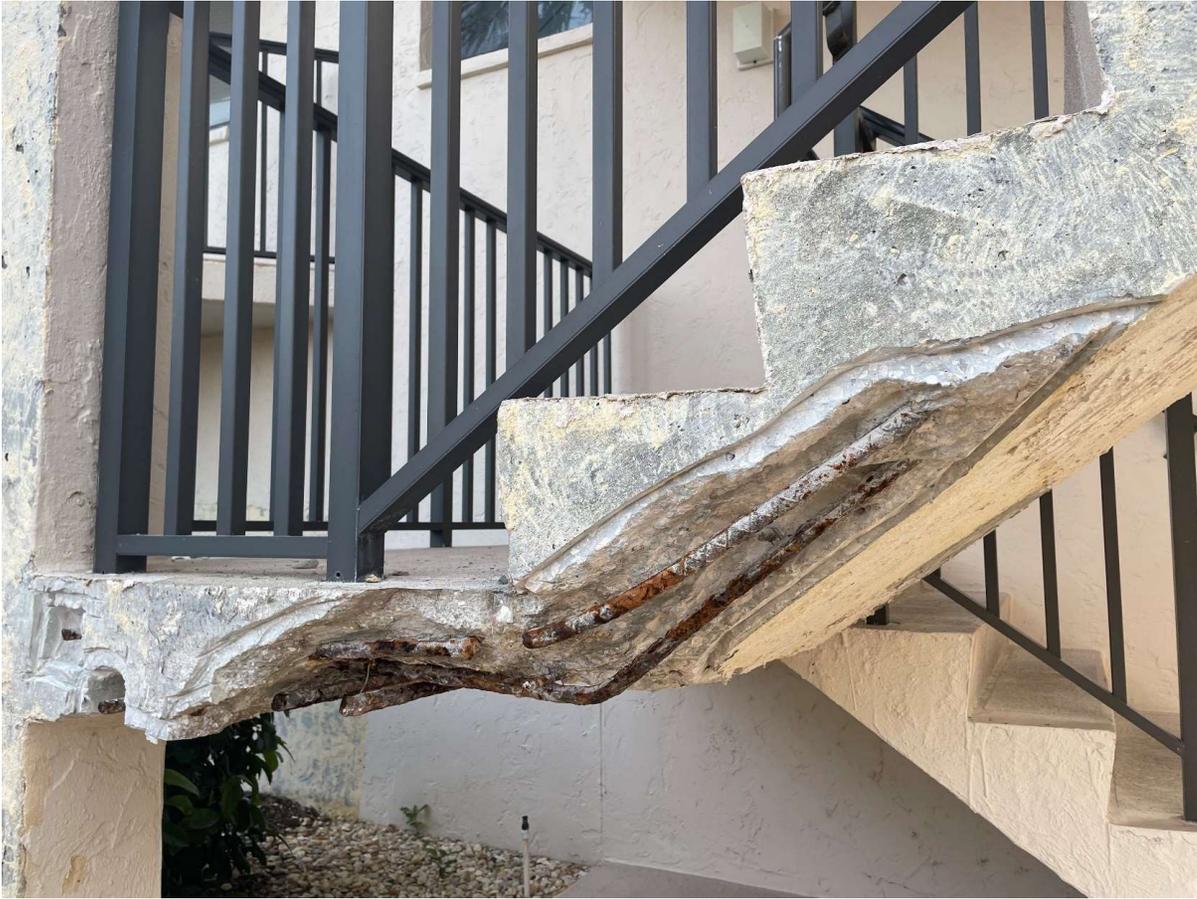
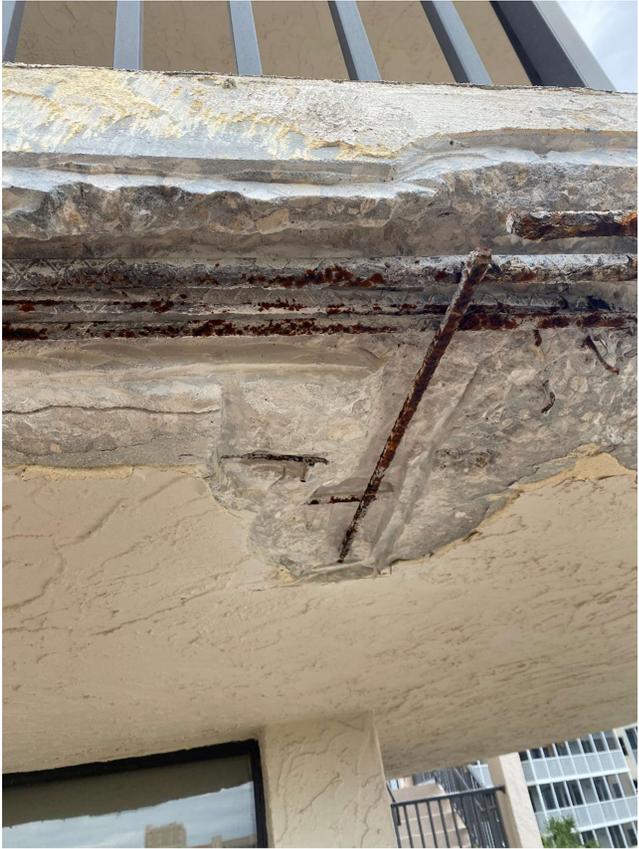
Gulf Building Photos

- We also have one stair landing with significant water damage and shoring has been added until the repair can be made. This west stairwell is closed until repaired and can only be used for emergency purposes.
