# Gulf Building Update

10/6/2021

# Construction Summary

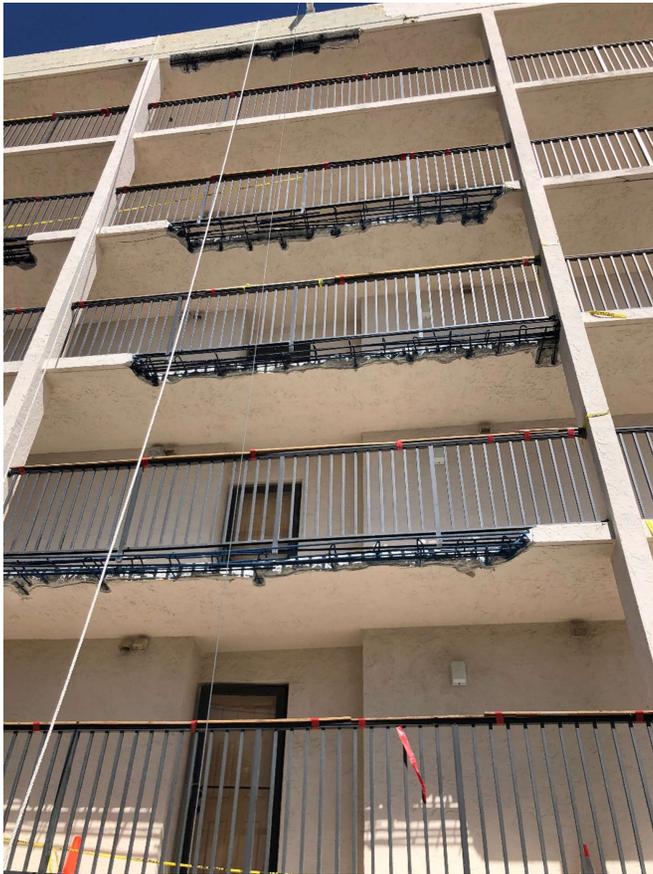
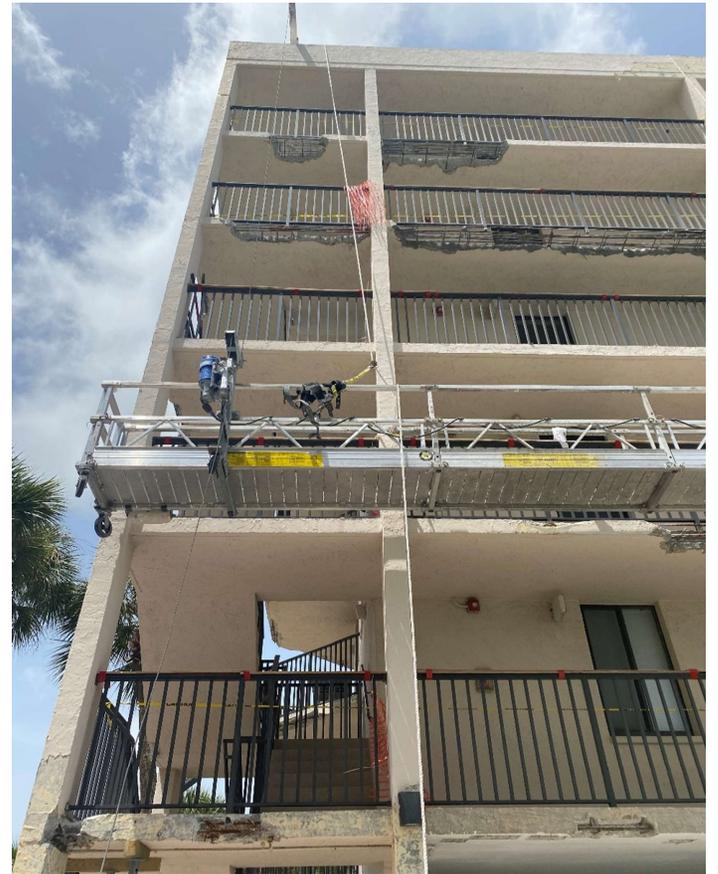
# Photos – Walkways – Sept 20th

- The issues at the Gulf Building are much more profound than expected due to salt and water intrusion.
- We have found a great deal of rusted rebar, delaminated stucco and concrete failure both on the lanais, stairs and walkway edges as the first section of renovations have begun.
- We have had to remove the tile from the first tower (X01) of lanais due to water pooling under the tile and causing damage within the concrete surface.
- We will no longer allow for tile to be put on beach side lanais due to the inability to seal the tile surface over a long period of time.
- We are working on and must find a solution to waterproof the walkways and lanais once the renovation and painting work is done.
- At this point, the walkway concrete within the first two columns of the west end of the building has been poured and waiting to cure.
