Excelsior Restoration Update

7-30-21

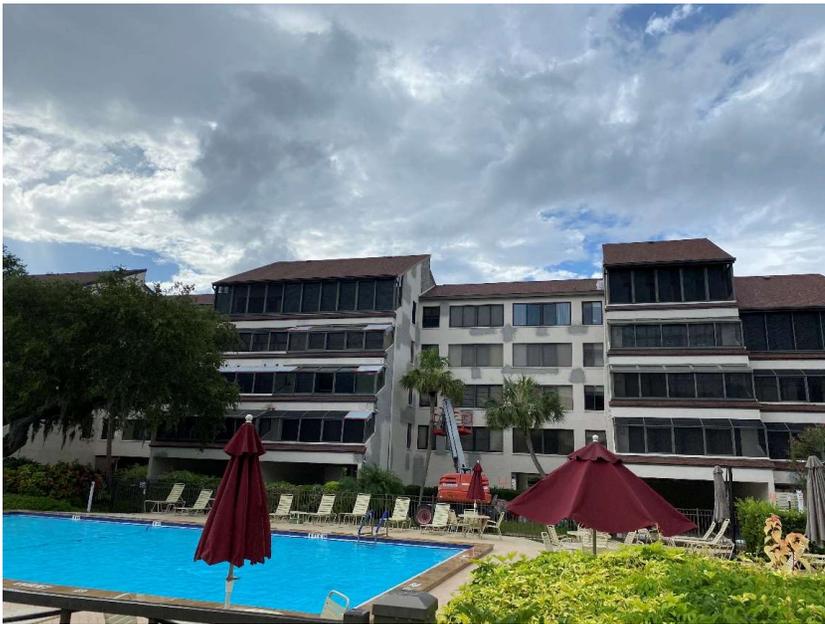
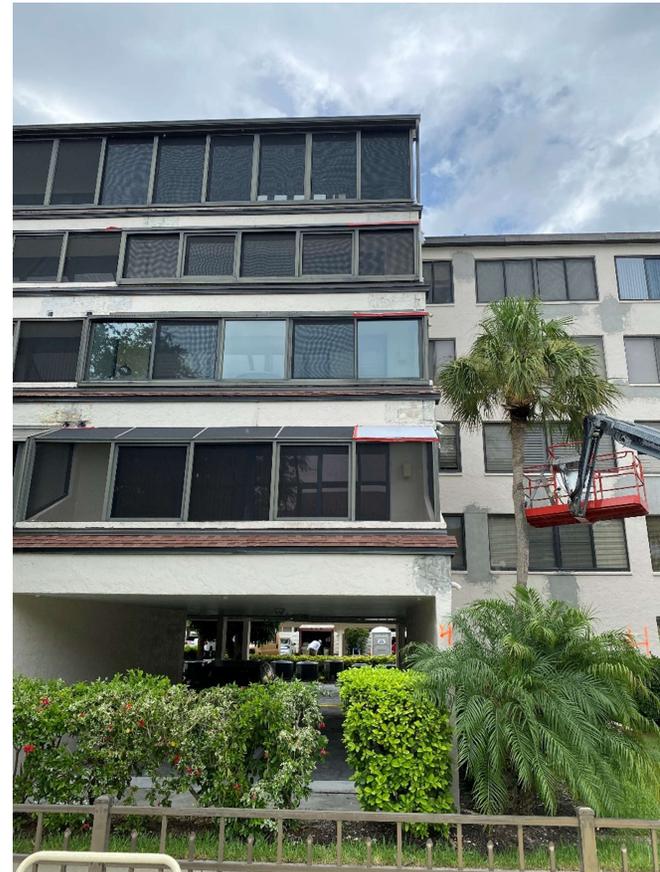
Restoration

- The chiseling of Section #4 by the pool is completed and repair and stucco has started. (The quiet work)
- Similar to Section #3, they have found very small amounts of concrete repair, but a great deal of stucco issues allowing water to get into the block. The majority of the stucco issues are around the drains that exit the lanais as you can see in the photos and the walls that extend above the roof line again.

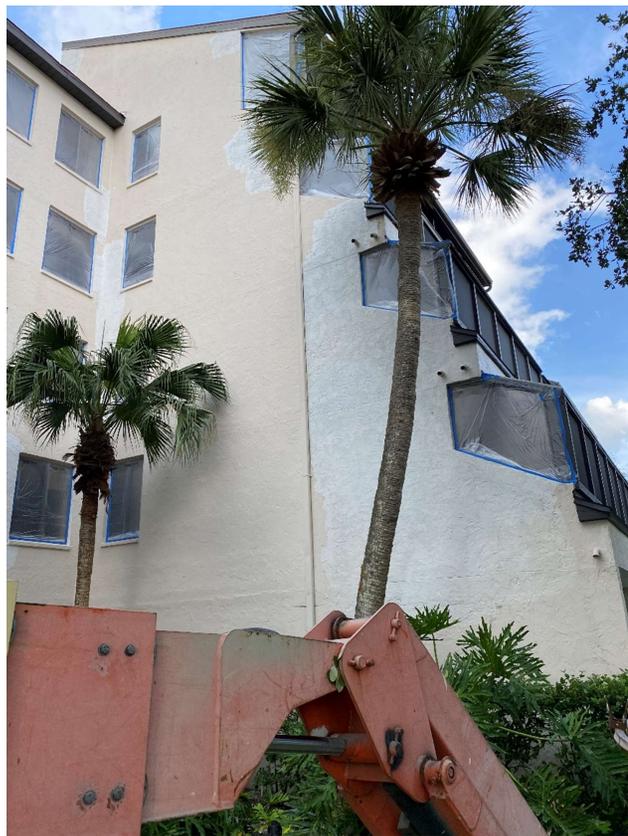
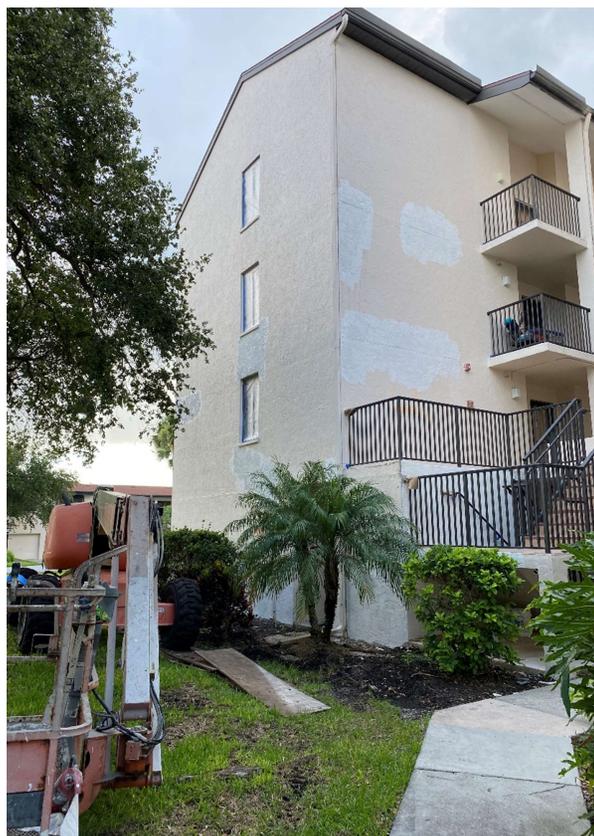
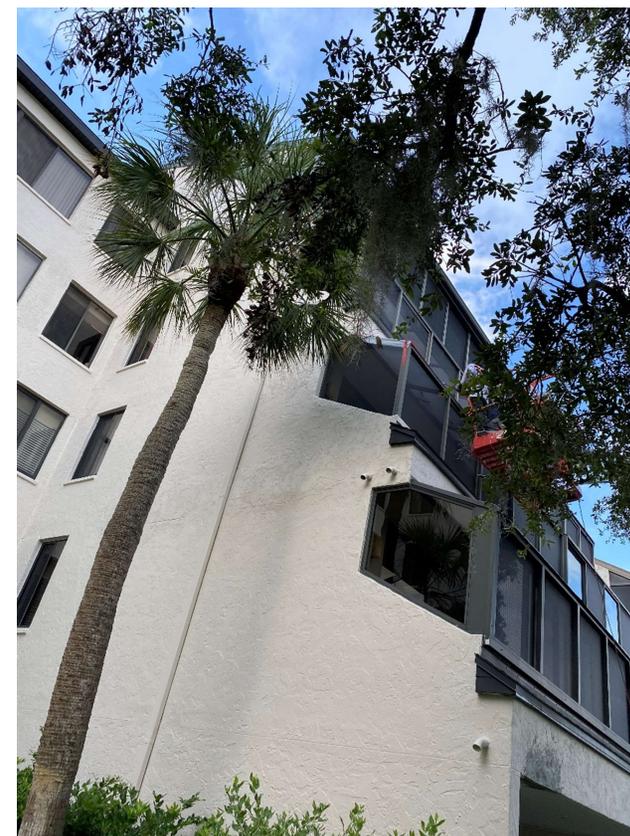
Painting Section #3

- Painting continues following the restoration work and they are currently painting section #3.
- For those owners on site, you will first see a primer coat on the building before the final coat is applied. (Don't panic the primer is a different color).

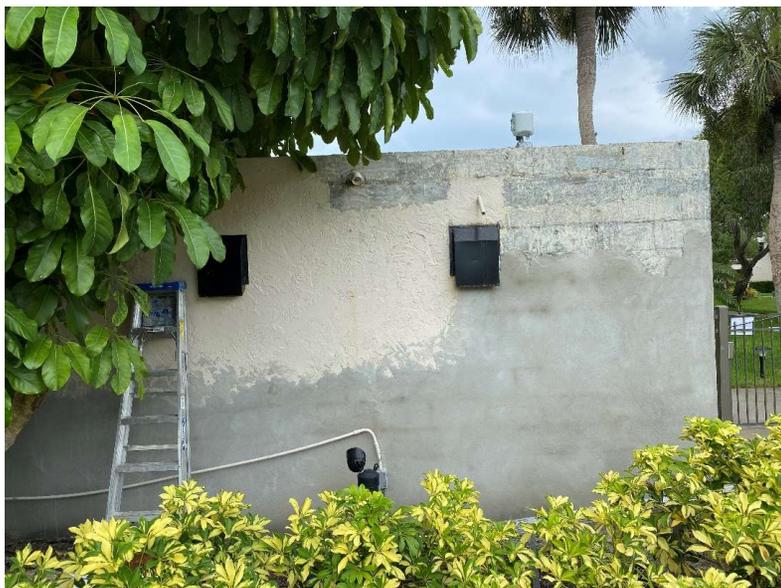
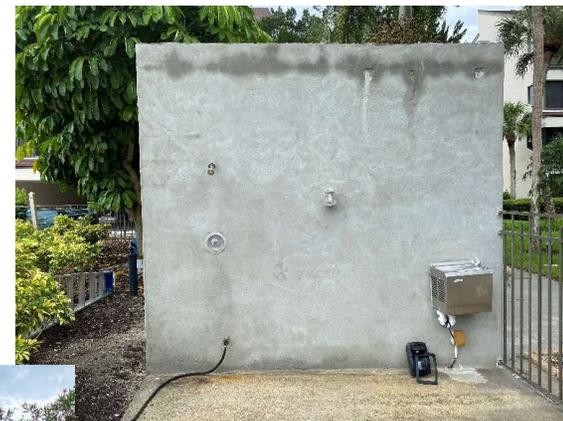
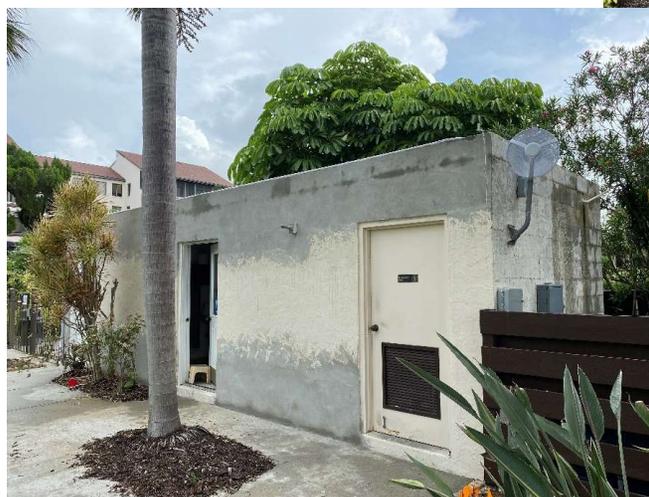
Pool House

- The pool building had a great deal of stucco issues especially on the north and south ends. The re-application of stucco has started.
- We are also adding a waterproofing to the pool house parapet cap to protect the stucco in the future. This will be looked at every few years and possibly recoated to protect the stucco and brick better for a longer life.
