Excelsior Restoration Update

8-13-21

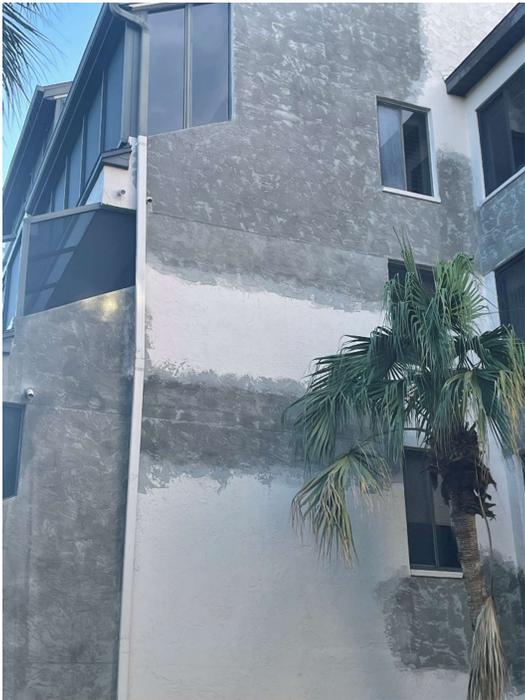
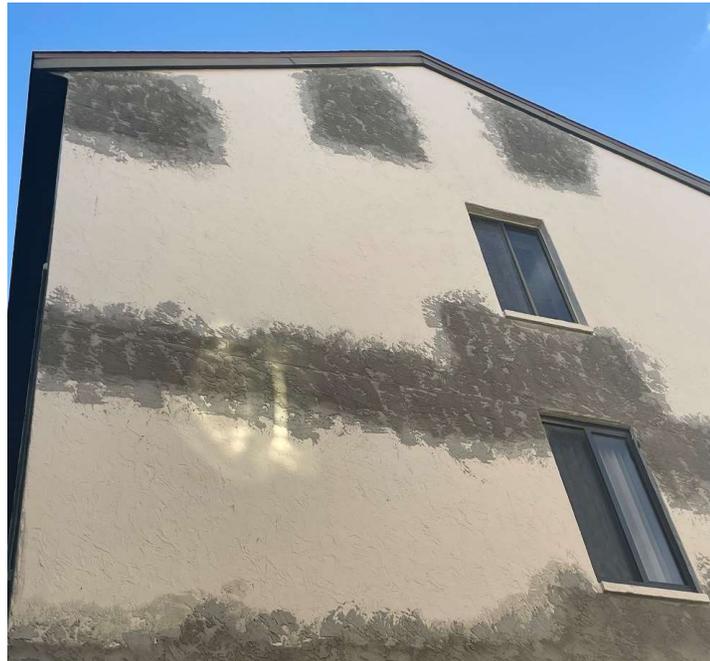
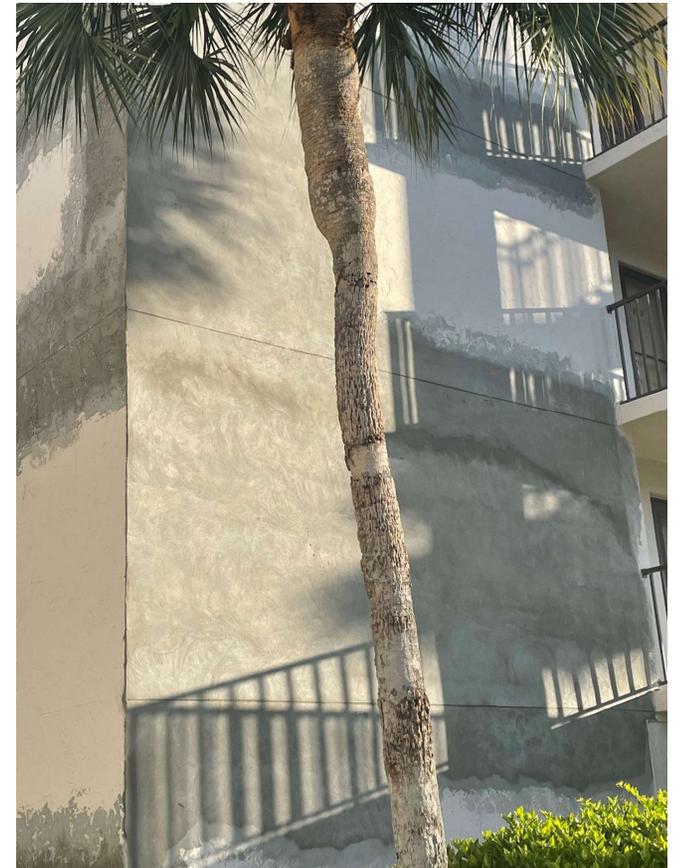
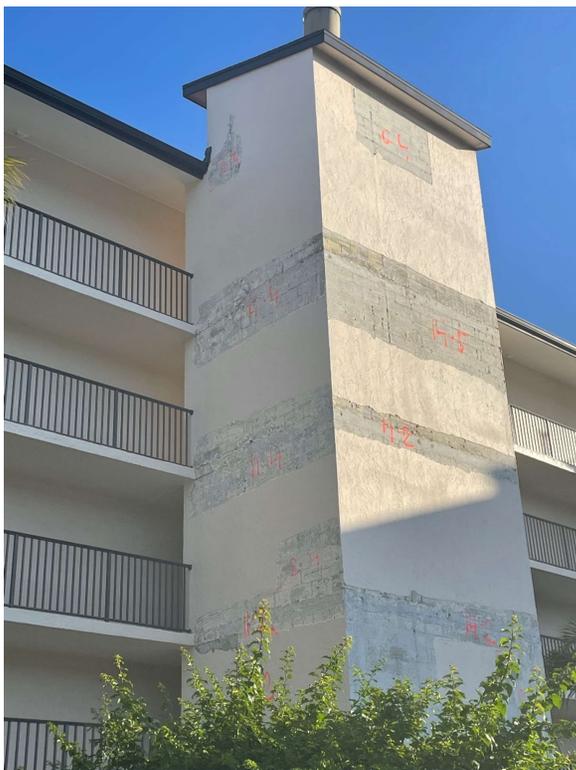
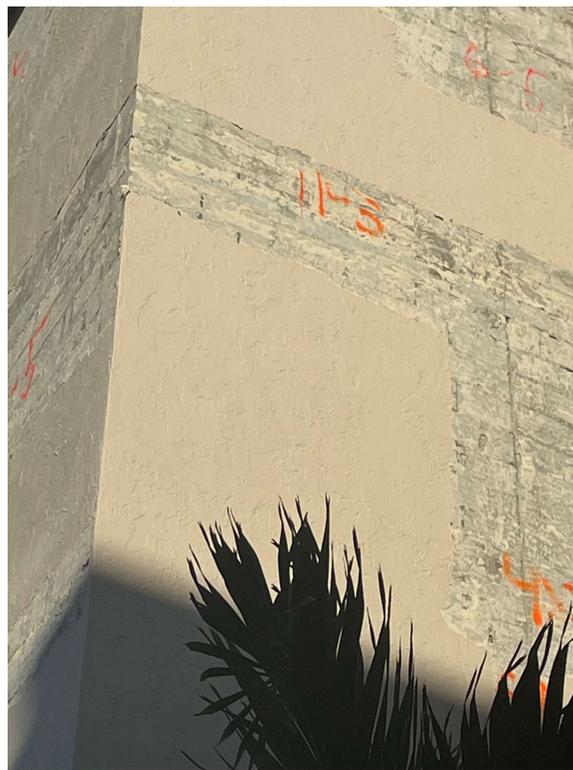
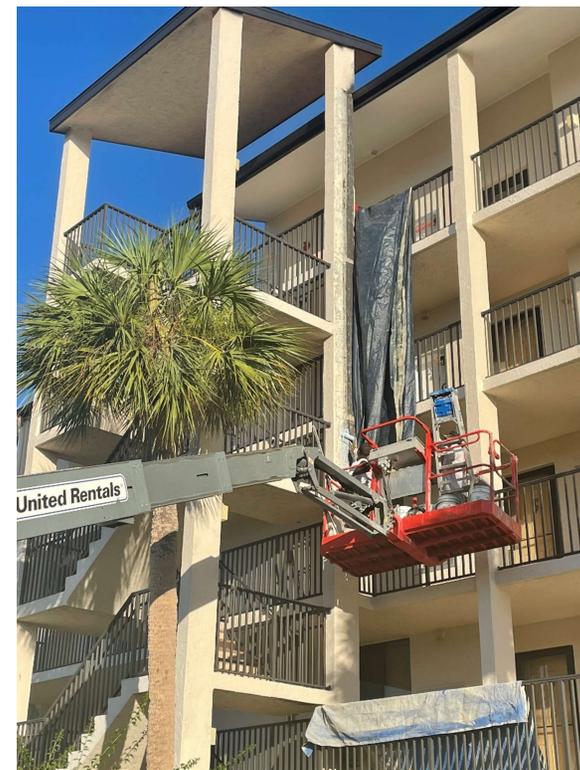
Building #5 Photos Restoration

- As can be seen in the photos below, a great deal of issues regarding stucco was found in sections #4 and #5, which were the west end of the building up to and including the elevator shaft. In these last two sections, nearly all of the stucco around construction joints and a great deal of mortar around the blocks needed to be repaired as water had gotten behind the stucco over time. Like great deal of other areas on the building, very little concrete repair needed, and no structural issues were found.

- Restoration work on Building #5 is completed.
- Both D&D and the painter had lost some time during the past couple of weeks due to the raining starting early afternoon for a number of days.

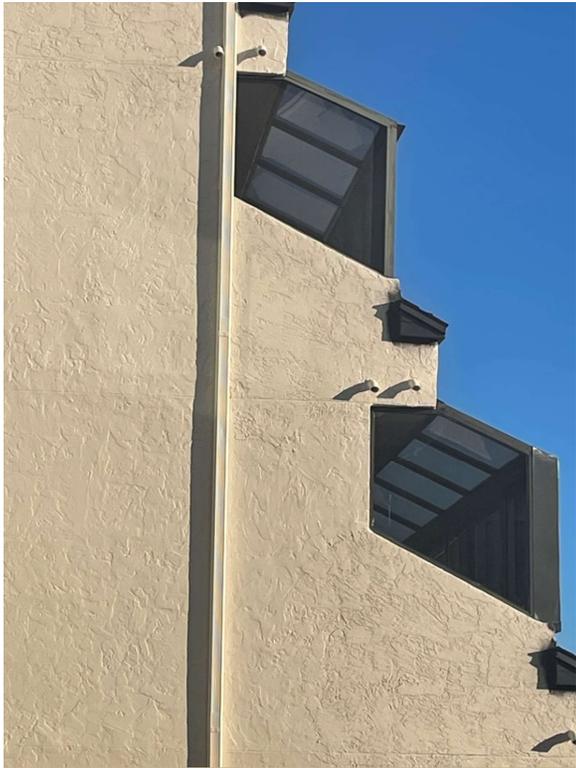
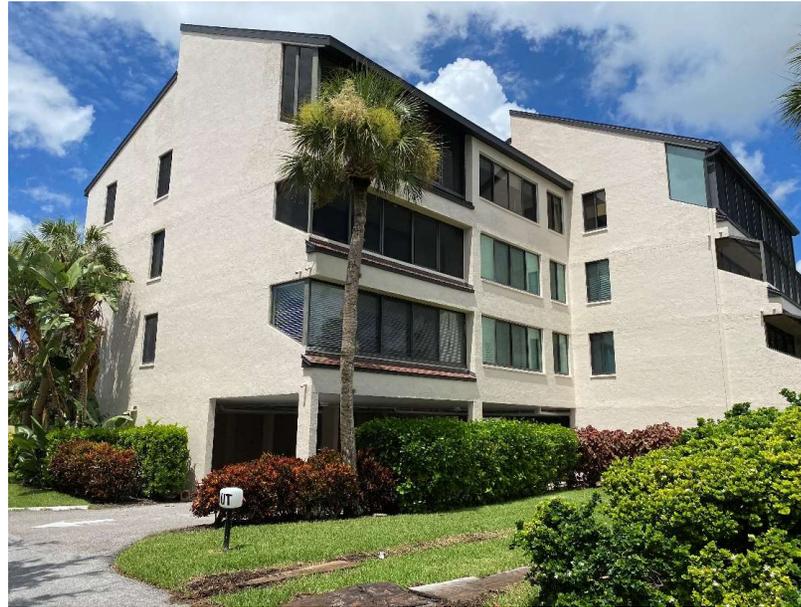
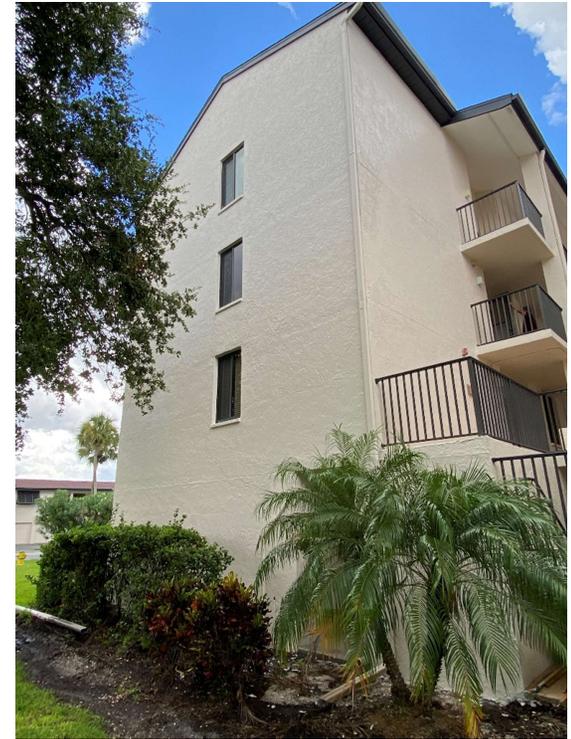
Building #5 Photos Painting

- Painting continues on Building #5 and should be completed by the end of Aug.
- There have been comments concerning the “odd” look of the newly repaired areas. We have looked into it and found that the “difference” in texture, color, shade etc... is actually from the fact that the old stucco has many more coats of paint and less “sharp” than the new repaired areas. The painting contractor has attempted to improve the look with different painting methods, but it is what it is without replacing all the stucco on all buildings.
