# Gulf Building Update

10/6/2021

# Construction Summary

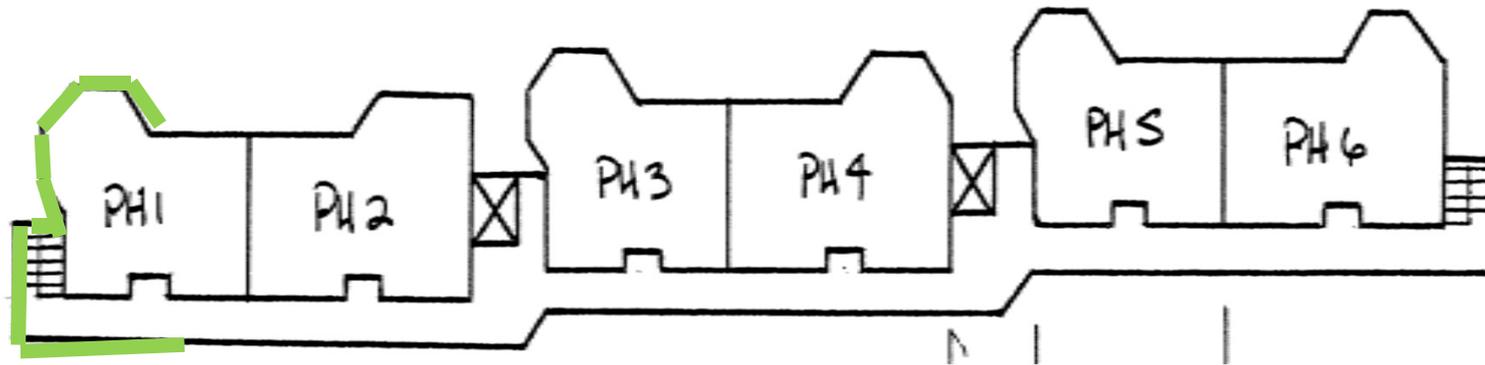
# Gulf Building Area – Current work zone

- The issues at the Gulf Building are much more profound than expected due to salt and water intrusion.
- We have found a great deal of rusted rebar, delaminated stucco and concrete failure both on the lanais, stairs and walkway edges as the first section of renovations have begun.
- We have had to remove the tile from the first tower (X01) of lanais due to water pooling under the tile and causing damage within the concrete surface.
- We will no longer allow for tile to be put on beach side lanais due to the inability to seal the tile surface over a long period of time.
- We are working on and must find a solution to waterproof the walkways and lanais once the renovation and painting work is done.
- At this point, the walkway concrete within the first two columns of the west end of the building has been poured and waiting to cure.
