# Excelsior Restoration Update

9-24-2021

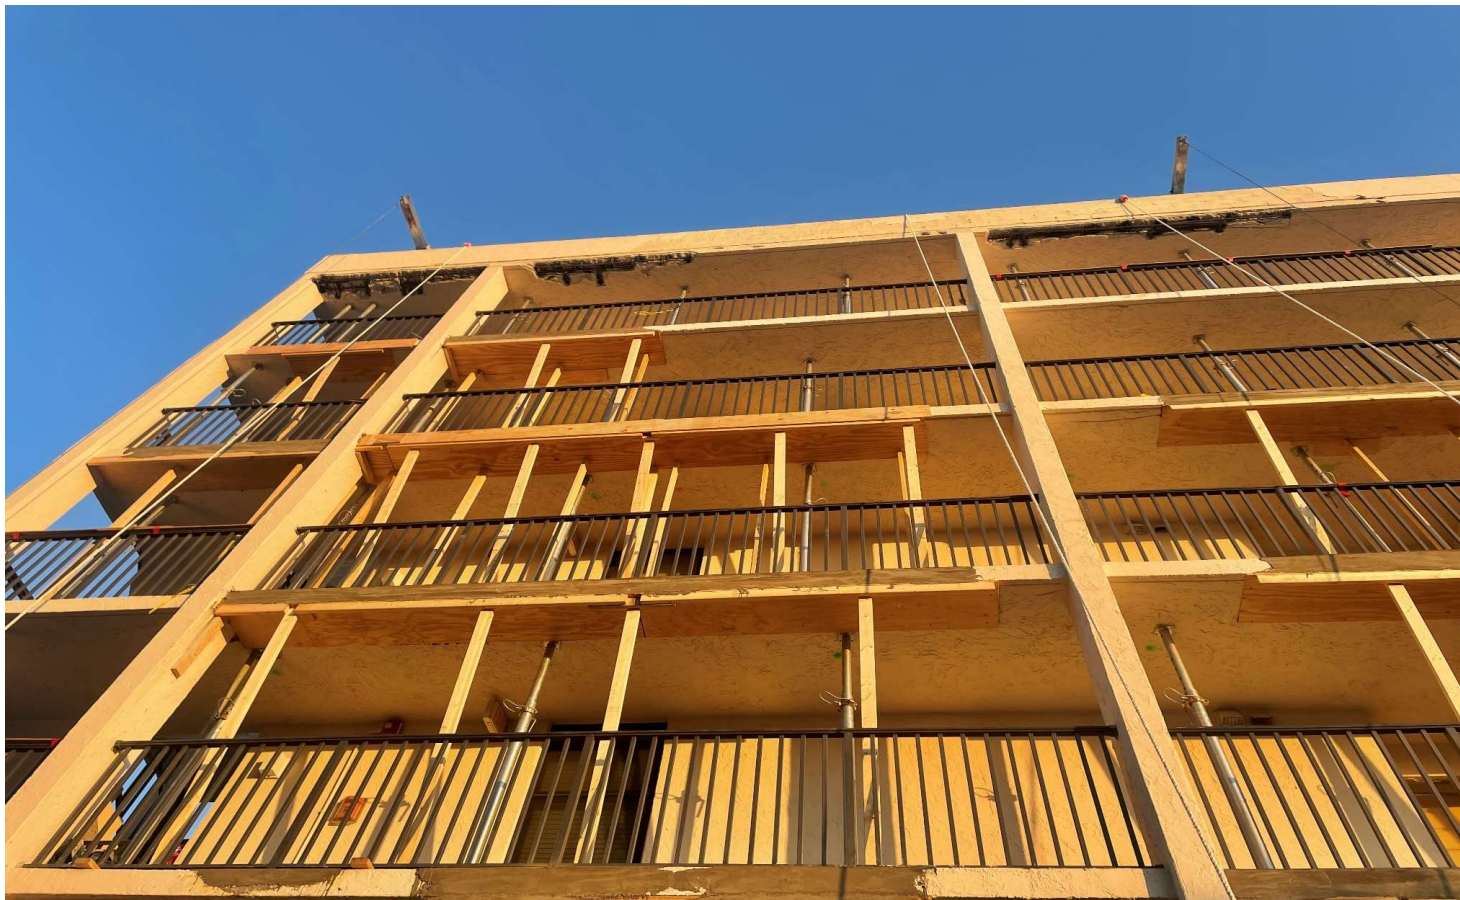
# Gulf Building Photos Restoration

- Gulf Building – Material removal on the walkways within the first two columns of section one are done and the concrete pours are completed. The support posts must remain in place for 14 days for full concrete cure.
- Work continues on the stairs and lanais.
- All the tile on the lanais of the first five floors (X01 Tower) have been removed due to evidence of water pooling under the tile and causing concrete damage. We are looking for replacement coatings for both the lanais and walkways as they will need to be coated very soon after the repairs to provide proper waterproofing.
